Manhole Inspection Summary

Manhole # S19K1_030MH

Insp Date: **5/6/08 10:19 AM**

Location Address: **3118 savoy st**

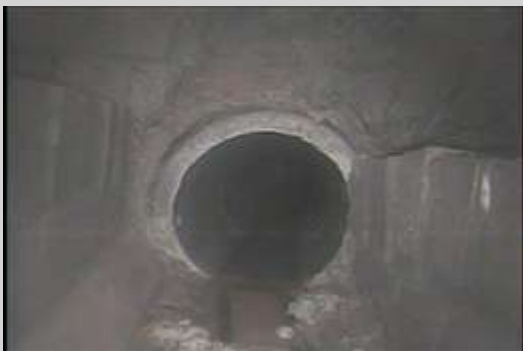
6 O'Clock Inflow

8 in. Circular Gravity Sewer
Pipe In @ 6 O'Clock

Pipe Height: **8.4** (in.) Rod and Bar (Angled)
Pipe Material: **Clay** ☐ Pipe Lined
Invert Depth: **9.23** (ft.) Flow Characteristics: **None**
Deposits: ☒ None ☐ Mud ☐ Sludge ☐ Debris ☐ Grease
Silt Depth: **0** (in.) Deposits Extent:
Infiltration: **None** Pipe Seal Cond: **Sound**
